**Flood Control Project Maintenance
Levee Inspections**

Maintenance Issue Types Only, Levee Inspection Report By Mile - Fall 2014

Reclamation District No. 2035 Conaway

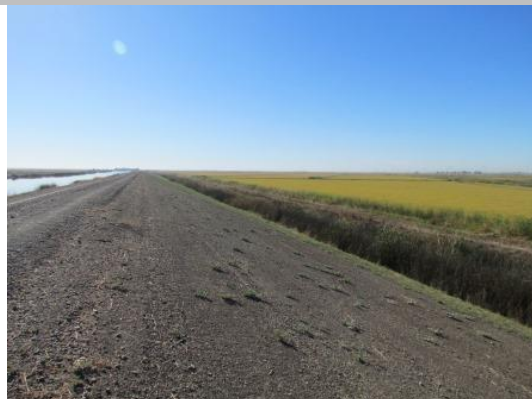
Photo 1 of 1 : FA_2014_RD2035_239_1_20141013_00003.jpg

LM Start	2.16	Rating **	A	Issue No.	1
LM End	3.42	Issue Type +	Ma	Location *	LS
Category	Earthen Levee			GPS Latitude/Longitude	
				Start	End
Item	Vegetation			38.646063 °	38.646063 °
				-121.666332 °	-121.666332 °
DWR ID	DWR_RD2035_02_f_2014_1				
Action/Comments					
Control annual grass and weeds on the levee slopes and easements.

This photo was taken from the crown facing south looking down the landward levee slope at acceptable vegetation maintenance. Fall 2014.

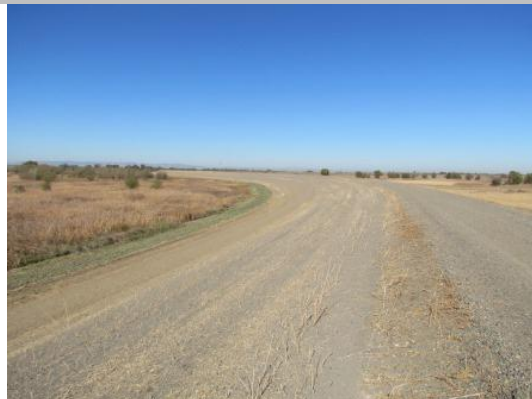
Photo 1 of 1 : FA_2014_RD2035_240_1_20141013_00003.jpg

LM Start	0.08	Rating **	A	Issue No.	1
LM End	0.08	Issue Type +	Ma	Location *	WS
Category	Earthen Levee			GPS Latitude/Longitude	
				Start	End
Item	Vegetation			38.575615 °	38.575615 °
				-121.659942 °	-121.659942 °
DWR ID	DWR_RD2035_03_f_2014_1				
Action/Comments					
Control annual grass and weeds on the levee slopes and easements.

This photo was taken from the crown facing west looking down the waterward levee slope at acceptable vegetation maintenance. Fall 2014.
